# CRESCENTA VALLEY WATER DISTRICT

Agenda for the Meeting of the Engineering Committee  
of the Crescenta Valley Water District

June 28, 2017 at 9:00 AM

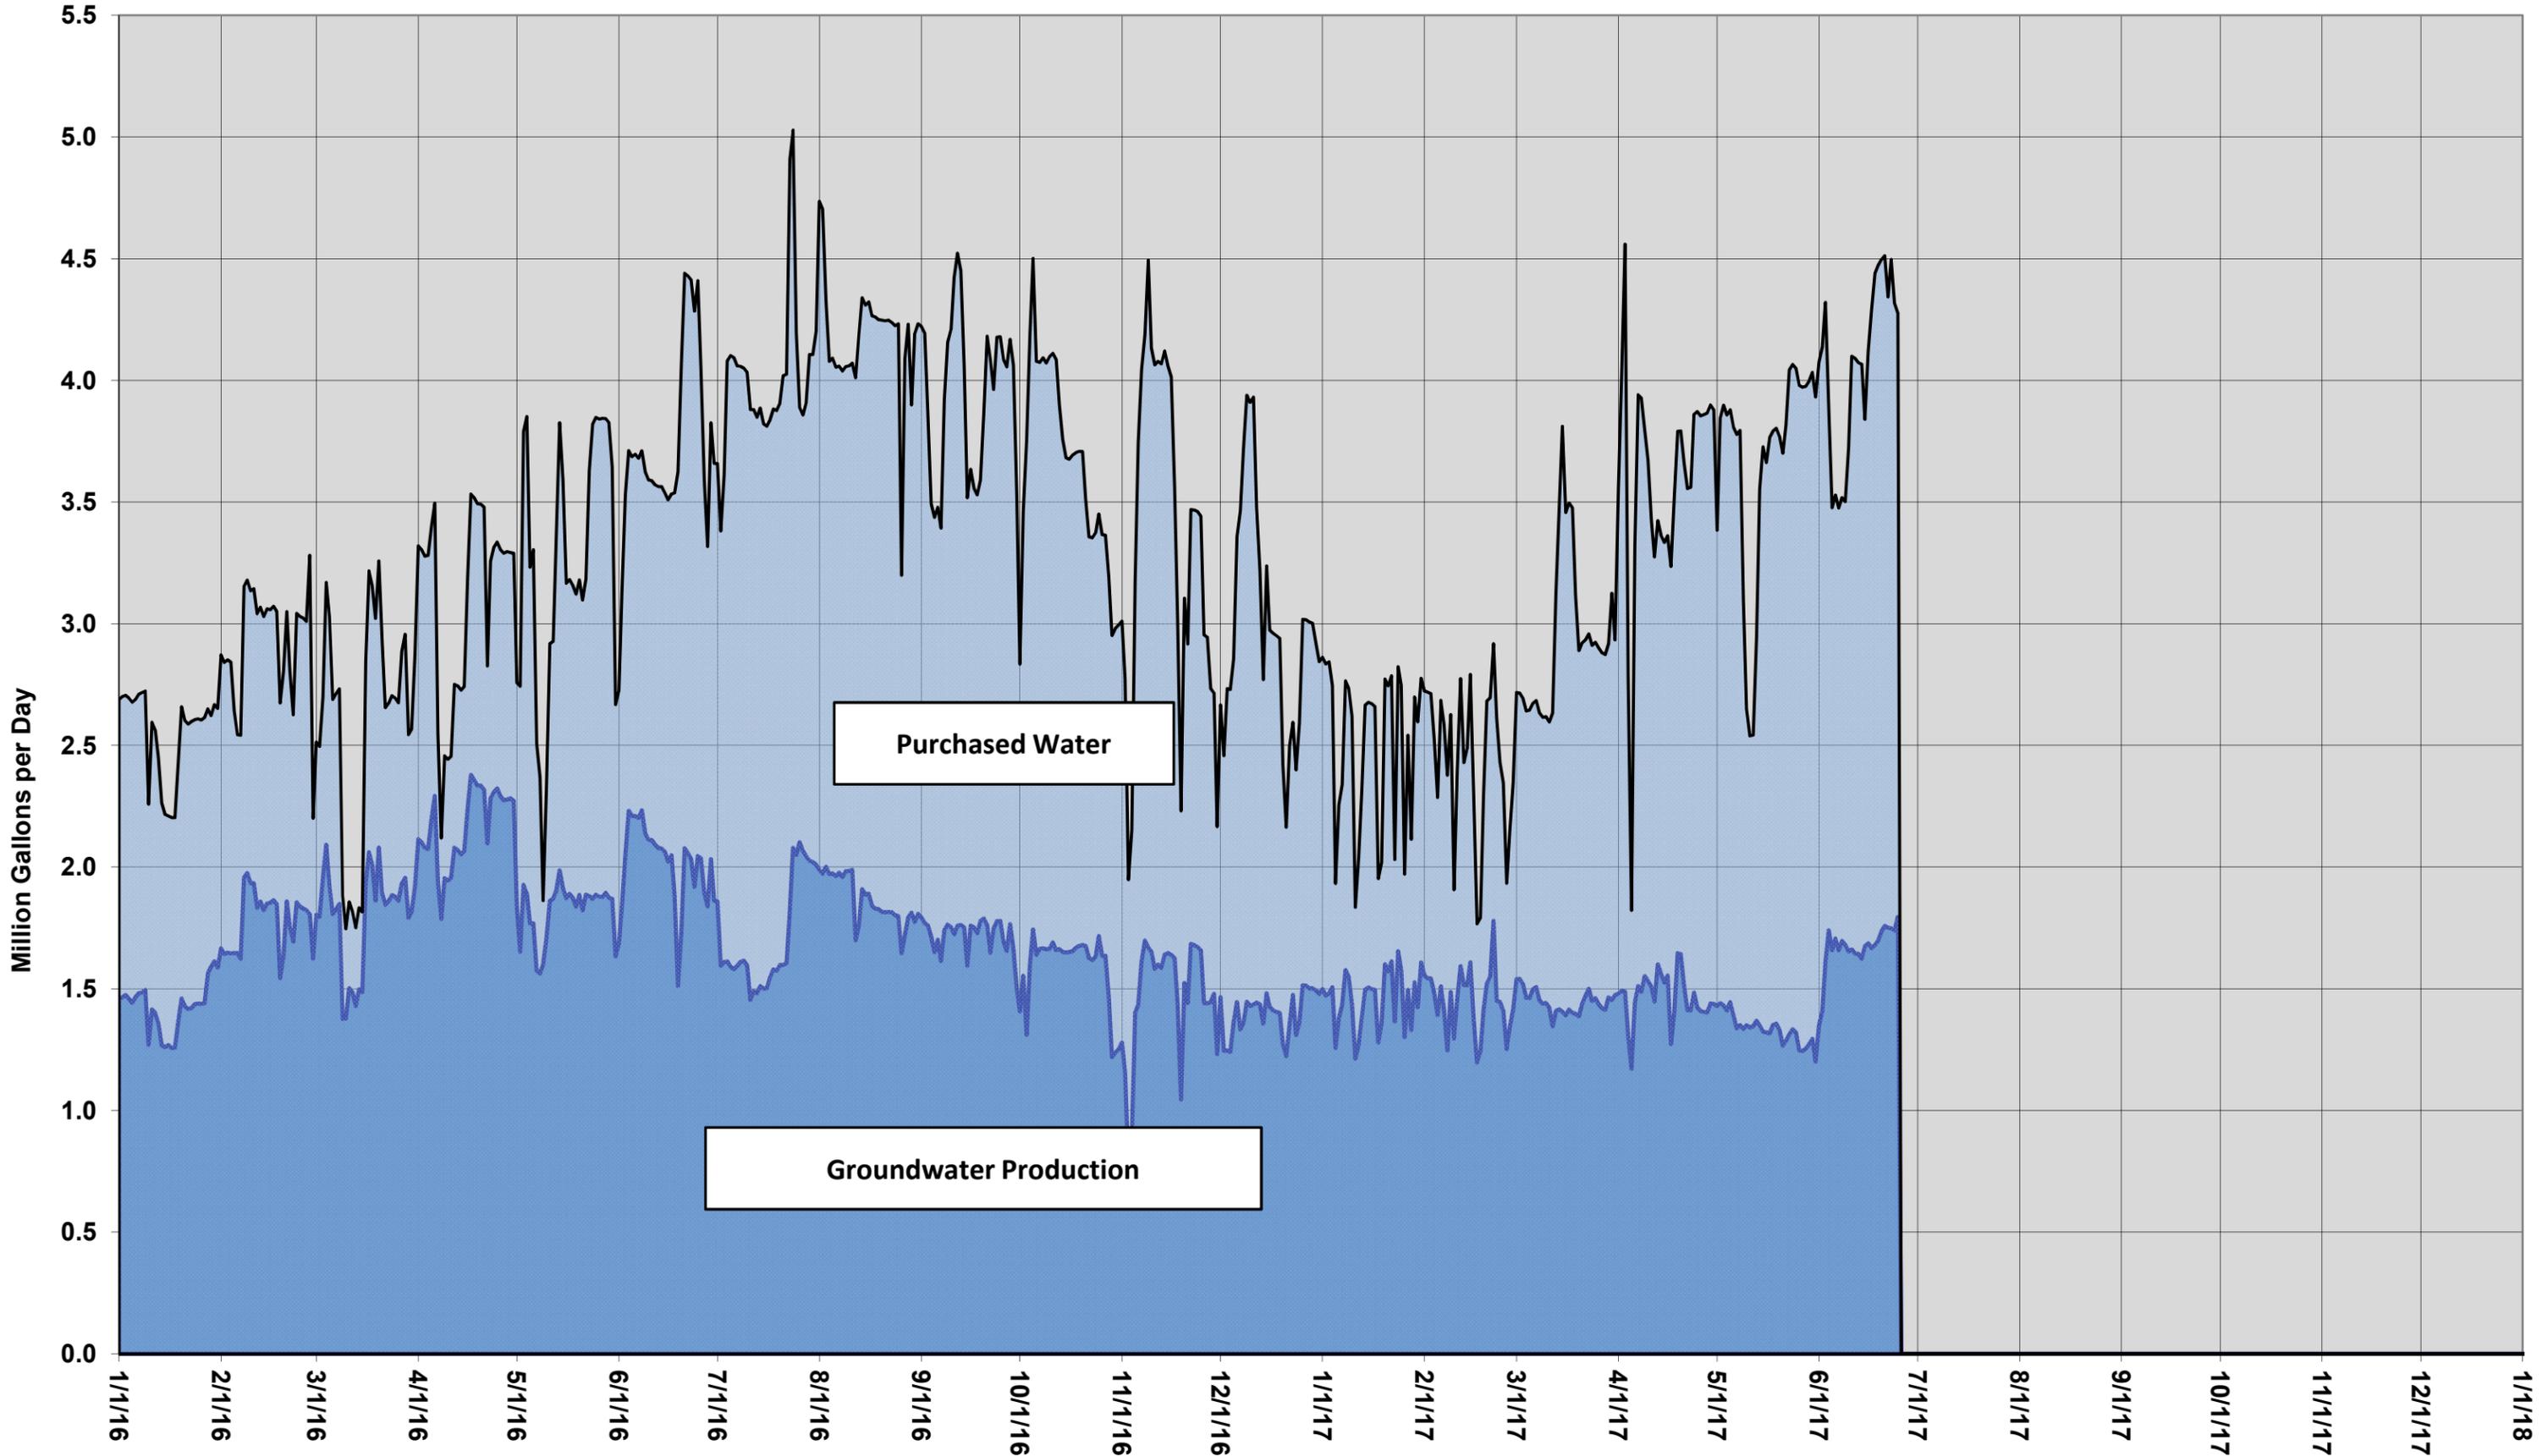
# Water Production Chart 2016 - 2017

■ Groundwater Production (MGD)    ■ Purchased Water (MGD)

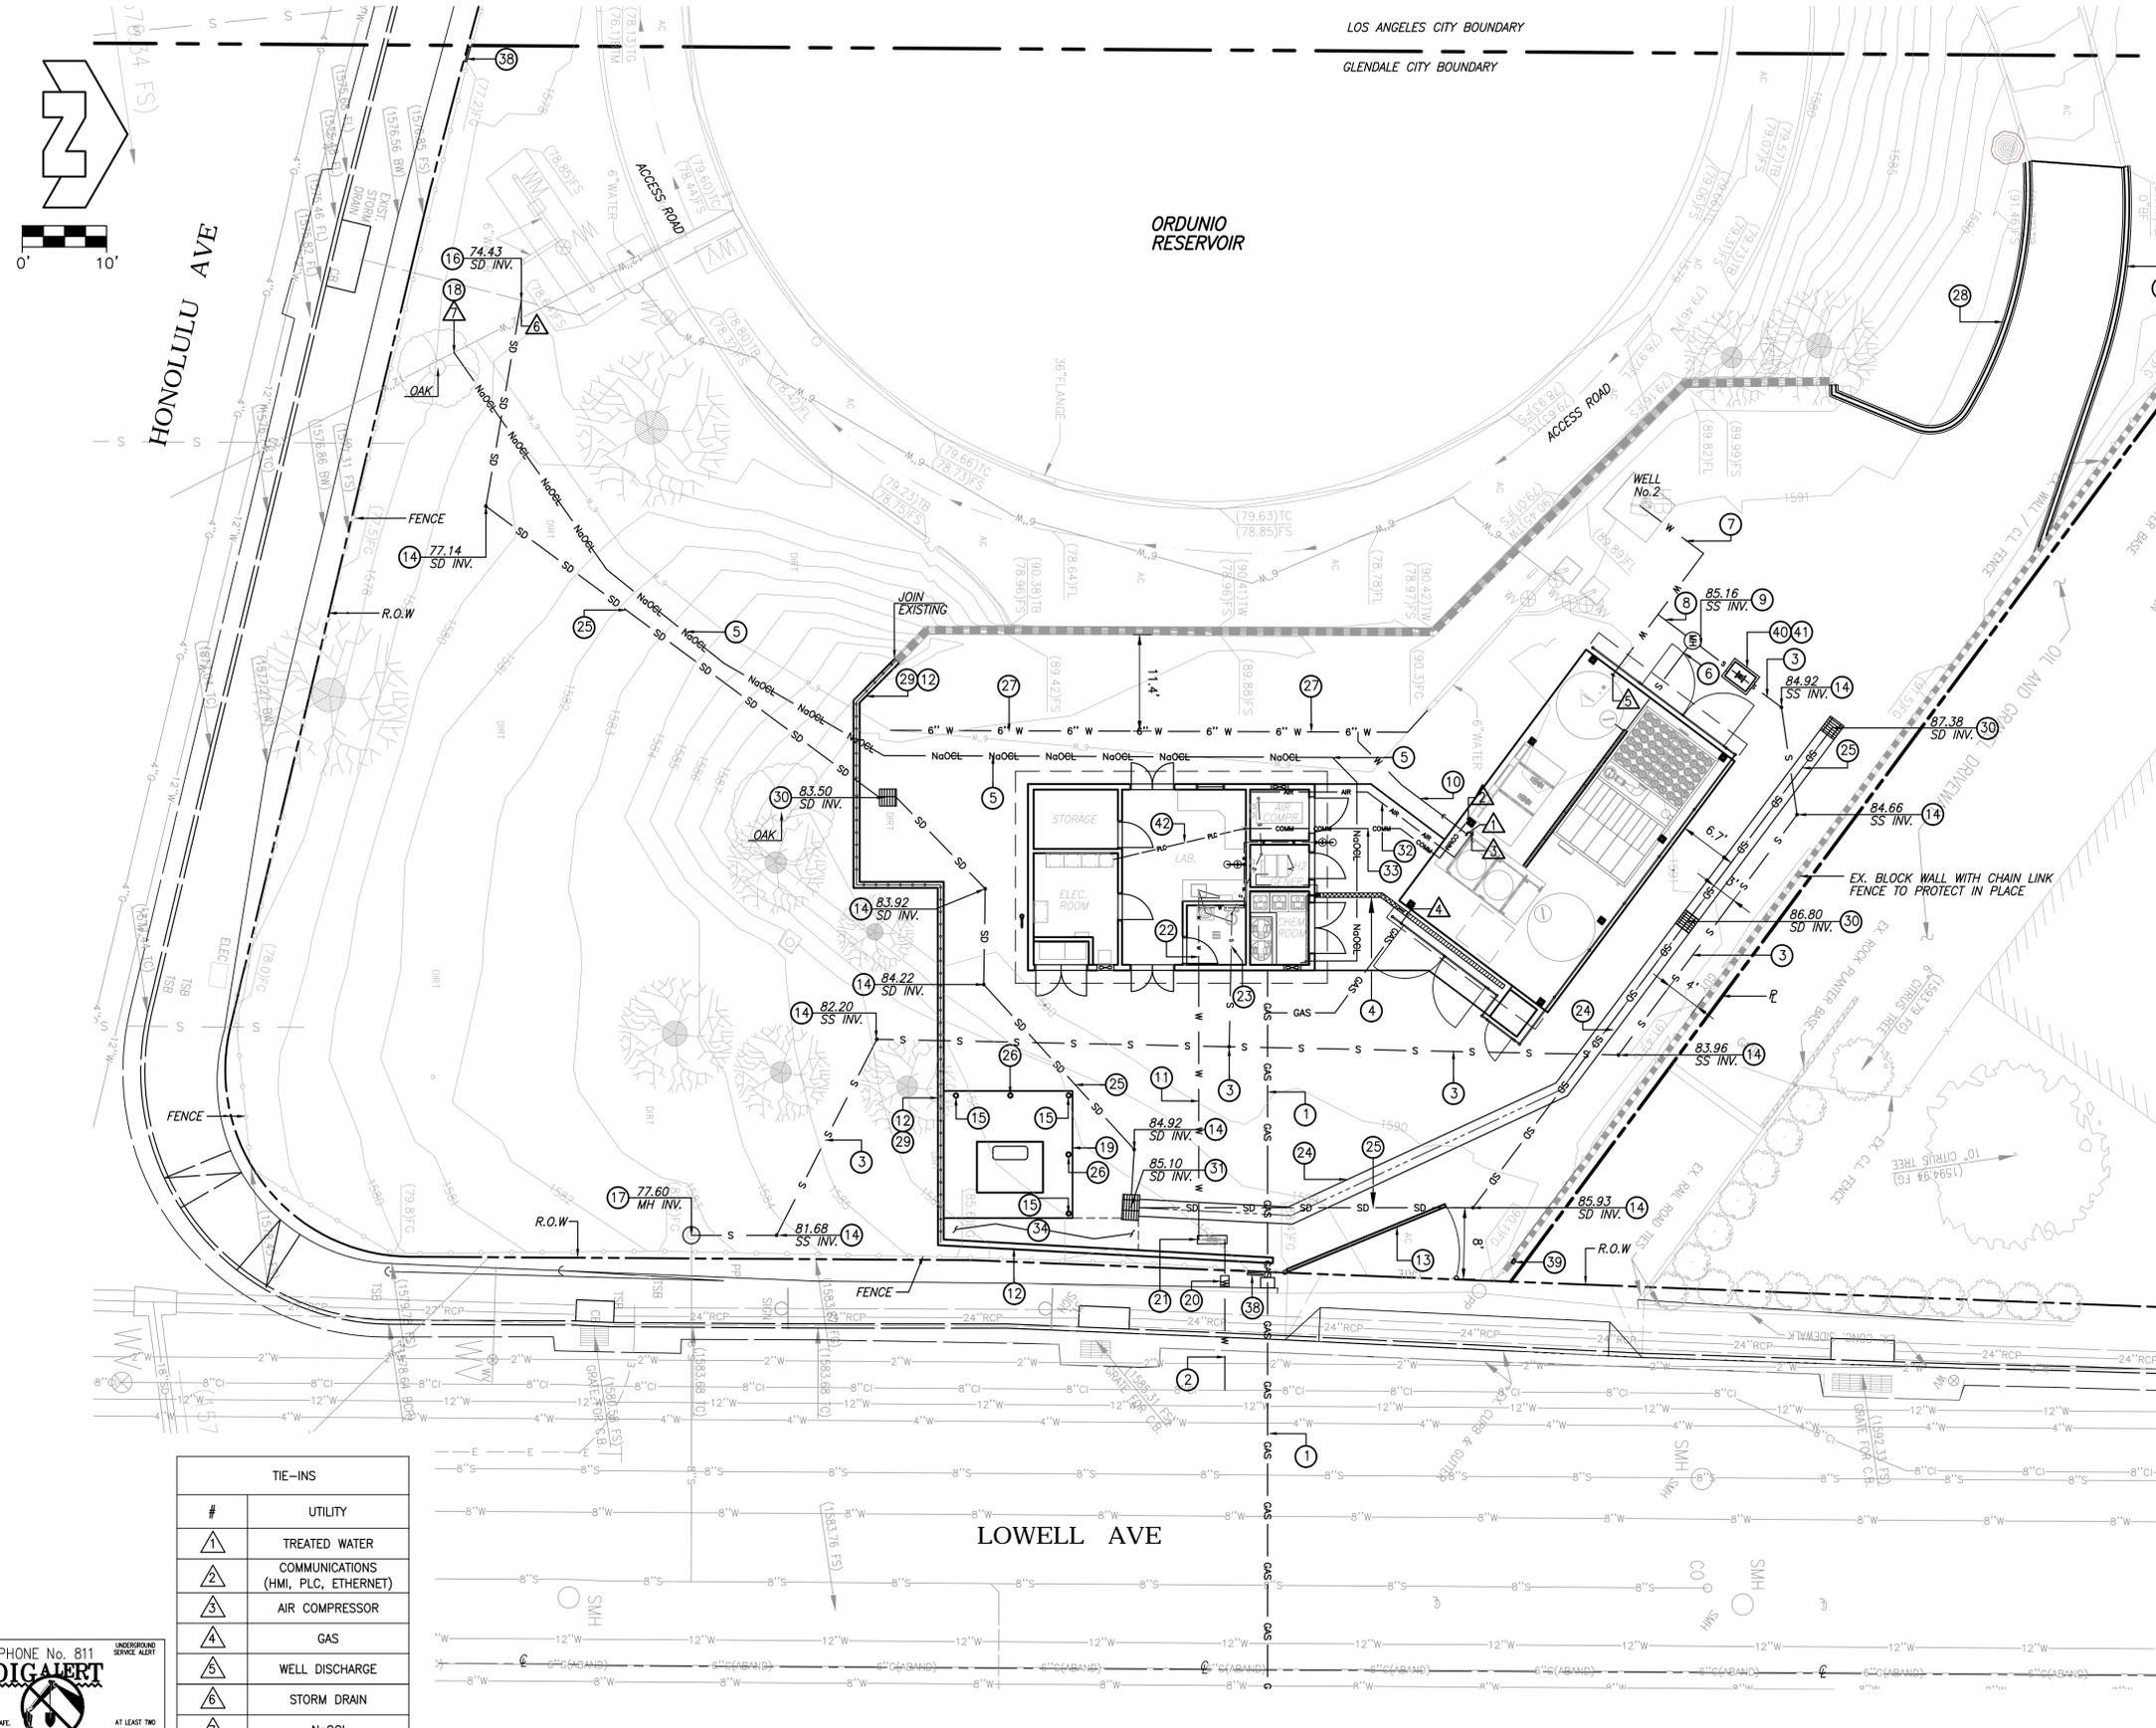
1. Site Plan for Well 2

**CONSTRUCTION NOTES**

- 1 FURNISH AND INSTALL 3/4" GAS SERVICE. FINAL LOCATION DEPENDING UPON COORDINATION WITH UTILITY
- 2 1" COPPER WATER SERVICE FROM EXISTING GWP - 8" CI MAIN TO METER. FURNISHED AND INSTALLED BY GWP

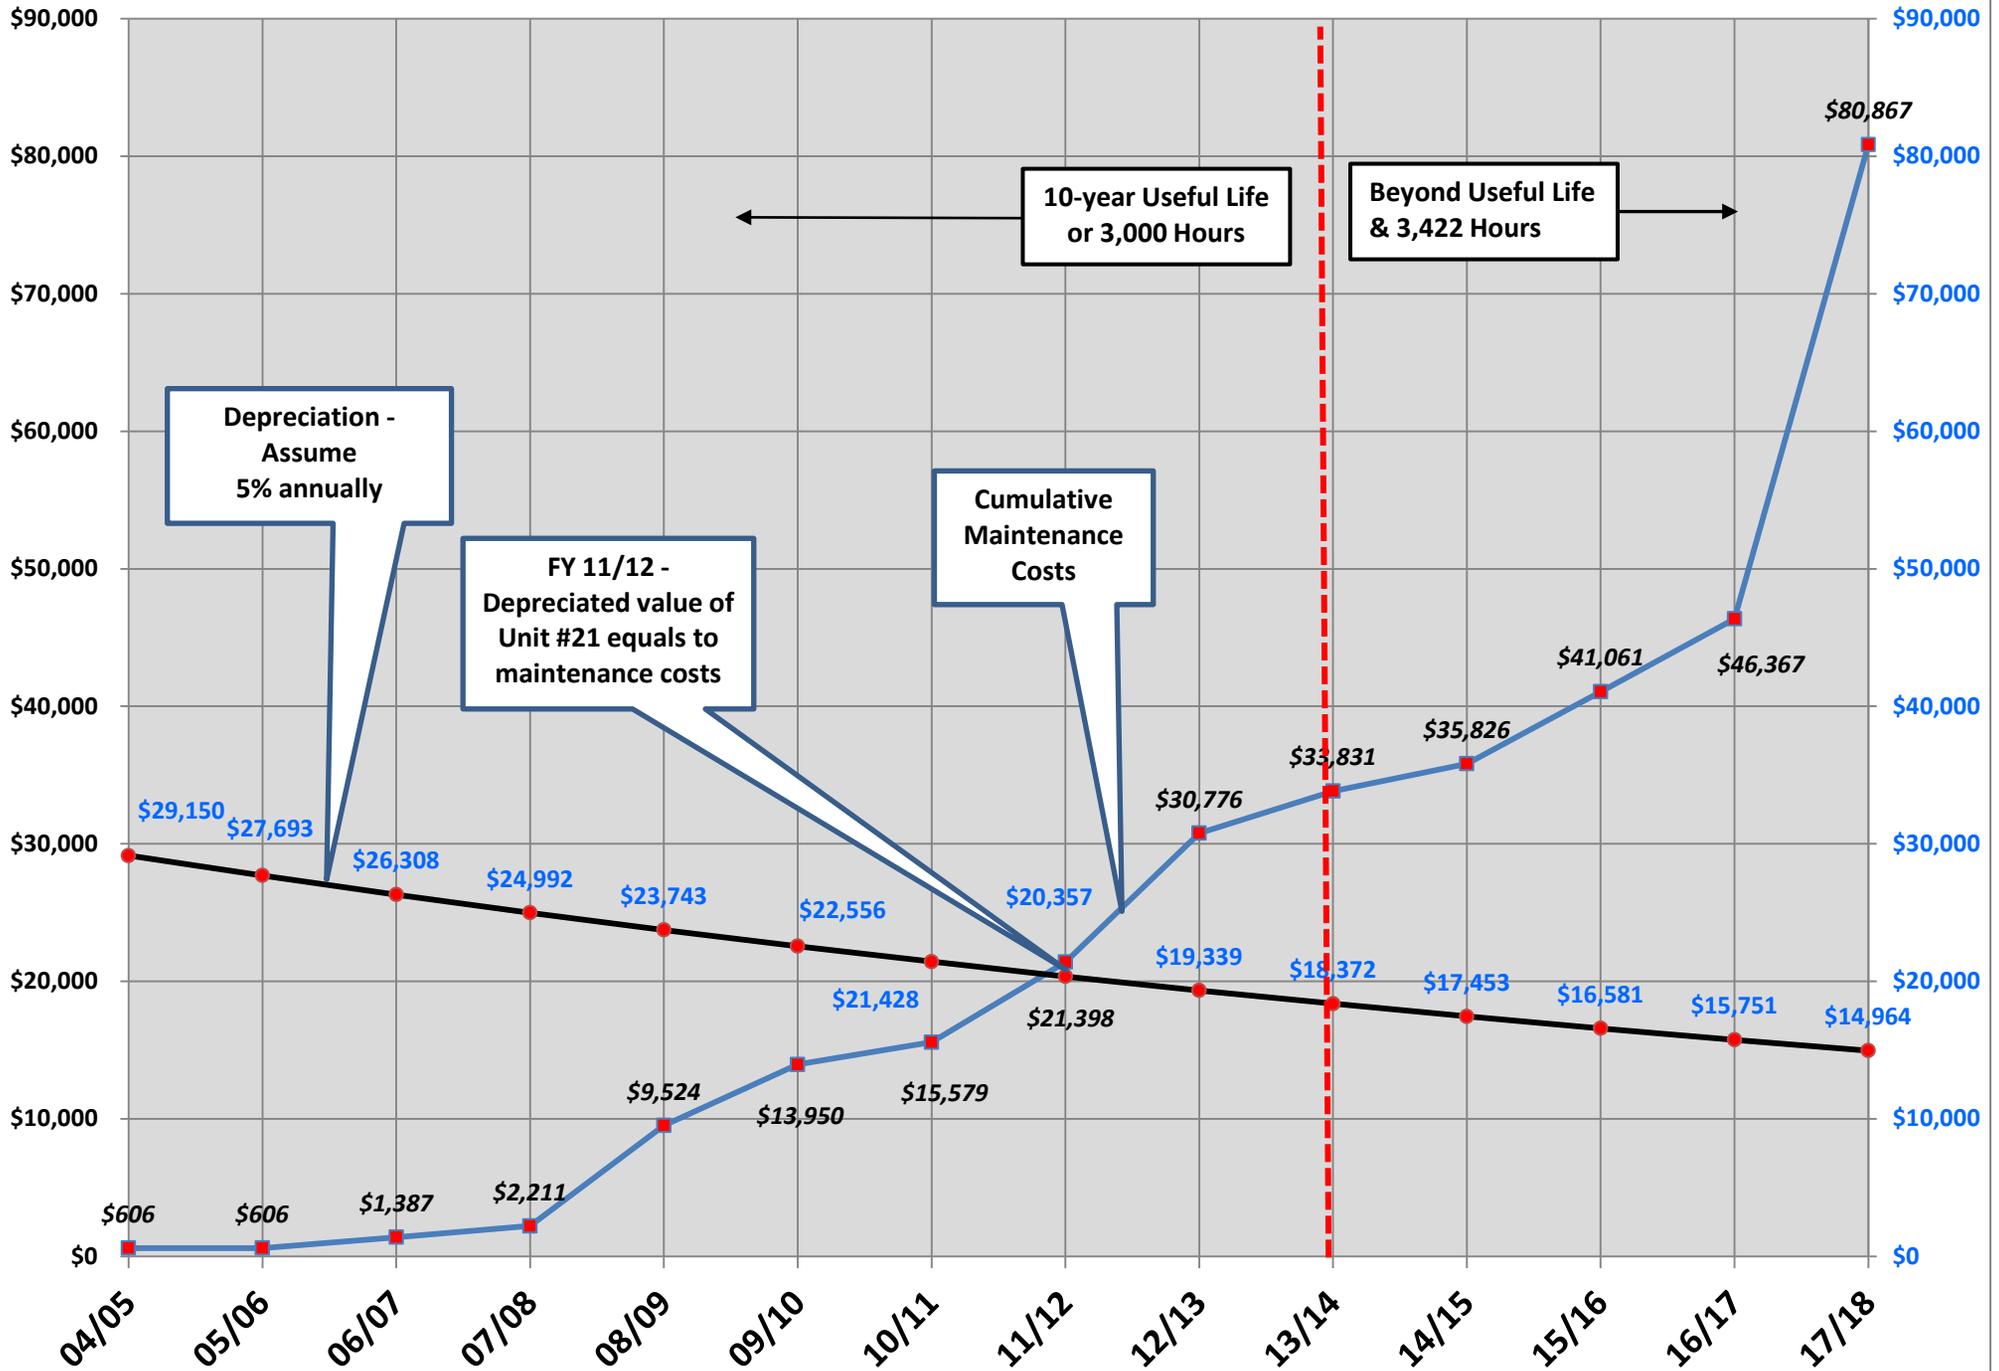
# Unit #21 - Depreciation vs. Maintenance Cost

Unit #21 is currently in need of repairs to the two (2) drive motors and the hydraulic pump, which runs the tractor. The estimates for these repairs are about \$35,000 and the parts would have to be shipped from the factory in Japan, since the parts are not stocked locally. The lead time for the new parts is 8 to 12 weeks and CVWD would have to rent a compact excavator during the interim period at \$250/day or an additional \$21,000.
